Automotive Components Group Marketing & Technical Service Department.

Appearance of a used spark plug tells a lot about the operating conditions of the engine and the plug. Thus the analysis of a plug plays an important role in the maintenance of a car. Perhaps this information can be used in explanations to consumers.

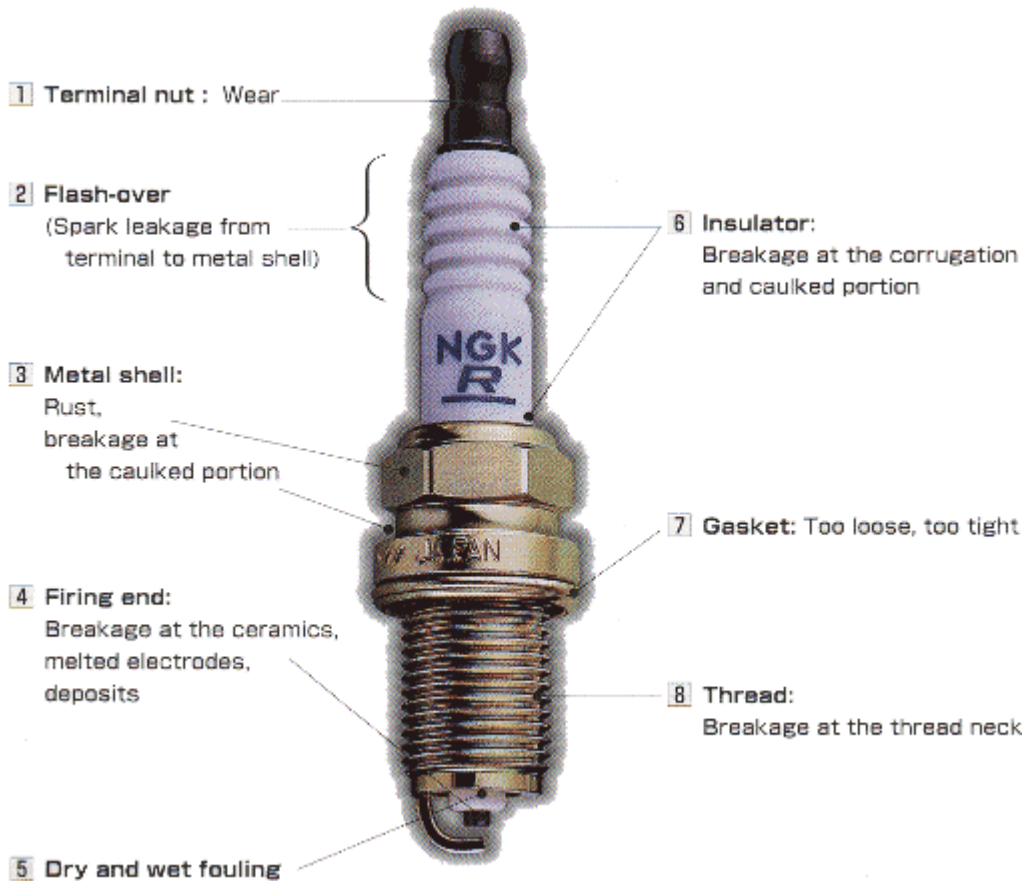
1 Terminal Nut : Wear

-Excessive vibration of the engine may lead to abnormal wear of the terminal nut. As a result, the cover may come off the plug. For vehicles whose engines vibrate more than others, such as watercraft and snowmobiles, solid post terminal plugs with excellent vibration resistance and wear resistance are recommended.
